# Winter Roof Damage Recovery

Luxury Residential A-Frame Cabin

Residential  
Donner Basin, CA

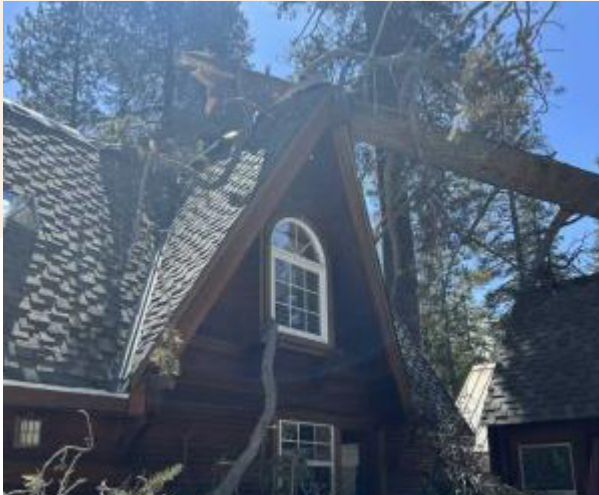
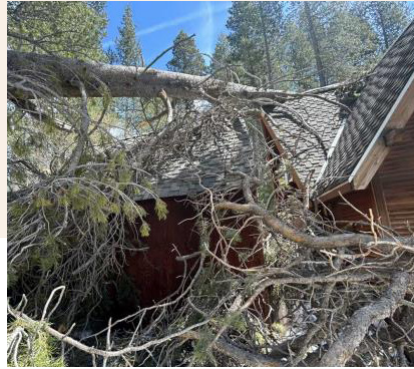
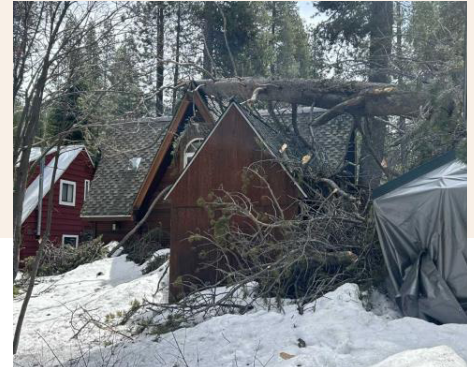
The cabin's steep roof pitch, exceeding 60 degrees, posed major safety and logistical challenges. A-frame roofs handle heavy snow well but are difficult to repair. ATI quickly deployed a skilled contractor for the job. Using belays anchored to the roof ridge, workers safely scaled the roof to replace damaged materials then glue and nail each shingle in place. ATI's focus on worker safety and precision craftsmanship ensured the project's success.

With winter fast approaching, ATI acted quickly to secure permits, materials, and skilled labor for the urgent repairs. The homeowner's temporary tarp was replaced with reinforced coverings to prevent further storm damage while supplies were transported to the remote site. Strategic planning ensured inspections stayed on schedule, and the team worked within short windows between inclement weather to replace and waterproof the roof. ATI's proactive approach safeguarded the cabin before it faced another harsh Donner Basin storm.
