Case Study

Mold Remediation on a College Campus

Weston, MA

Diagnostics and Dehumidification

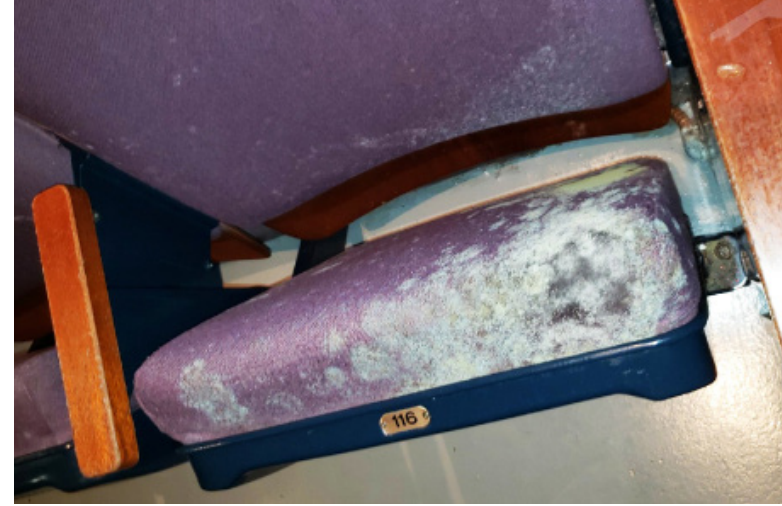
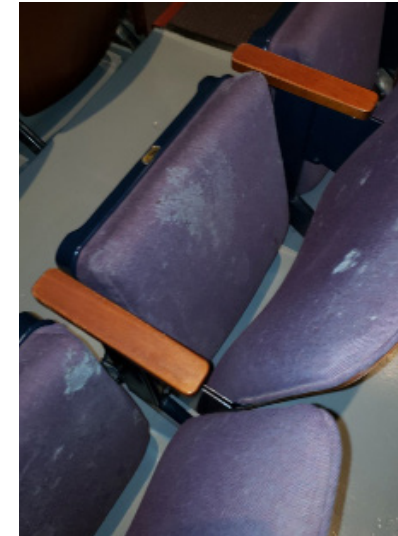
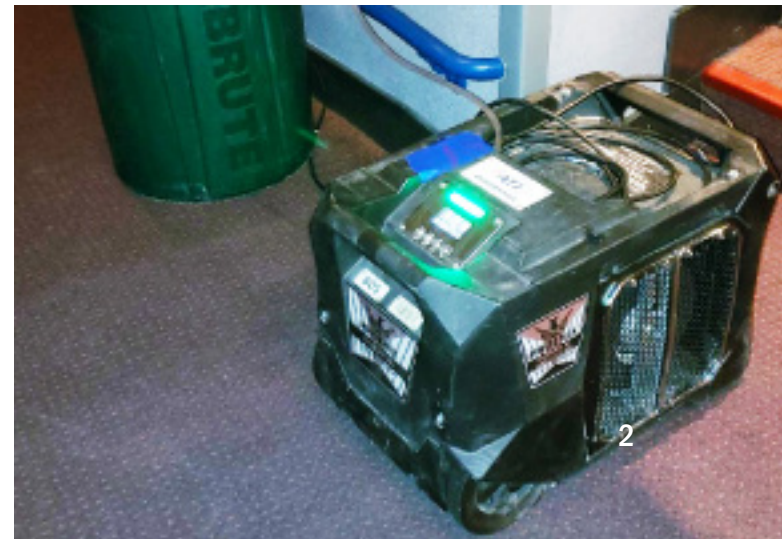
The high dewpoint combined with the high RH caused water to accumulate on surfaces, which led to a serious mold outbreak on upholstered chairs, carpet and sensitive audio and video equipment in the hall.

ATI's course of action included a highly complex diagnostic and dehumidification plan. Special drying equipment was used to remove moisture, and air-filtration devices were installed to promote air circulation and prevent additional microbial growth. ATI used state-of-the-art thermography equipment and moisture meters to monitor and maintain progress.

Within five days, the dewpoint was decreased, contents were dried and the auditorium was stabilized. After two months, ATI removed its equipment, salvaging the acoustical treatment and sound reinforcement systems in the theater, avoiding expensive replacement costs.
